VEHICLE INSPECTION REPORT

000054

7/4/09

<u>Make and model</u> HOLDEN HZ PANEL VAN 1979	<u>VIN / Chassis number</u> CH288244
<u>Registration number</u> UNREGISTERED	<u>Registration expiry date</u> UNREGISTERED
<u>Compliance plate date</u> 9/79	<u>Odometer reading</u> 358673KMS
<u>Engine number</u> OL998179

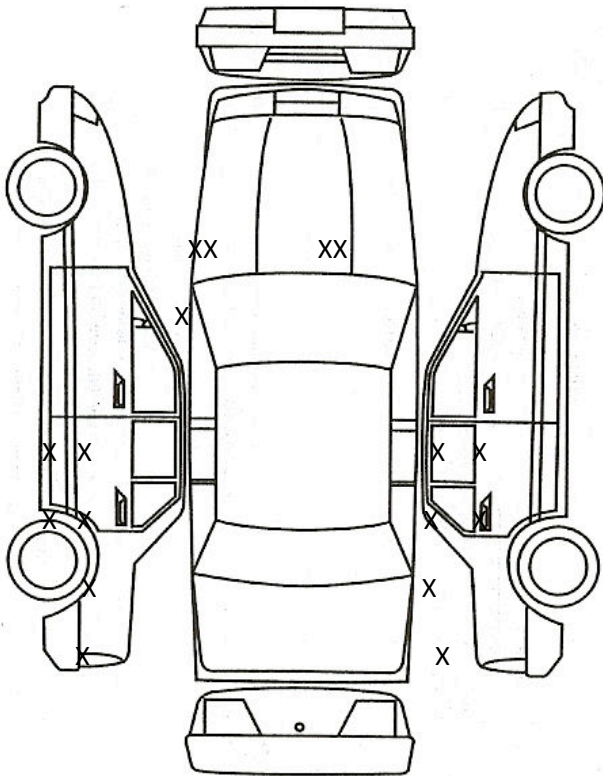
PAINT. VEHICLE HAS BEEN RESPRAYED. IS BLISTERING WHERE RUST IS. PAINT IS REASONABLE OTHERWISE. RUST. RUST IS PRESENT UNDER DASH ON PASSENGER SIDE. EVIDENCE OF WATER LEAKS UNDER DASH. RUST ON FRONT SCUTTLE. RUSTING WHERE PANEL VAN TOP MEETS BODY. EVIDENCE OF RUST IN SILLS.
